Proceedings of the 12th Conference of the  
International Committee for the Conservation  
of Mosaics, Sardinia, October 27–31, 2014

# Discovering and Safeguarding the Mosaics at the Pont del Treball Roman Villa in Barcelona

*Sílvia Llobet i Font, Montserrat Pugès i Dorca, and Anna Bertral i Arias*

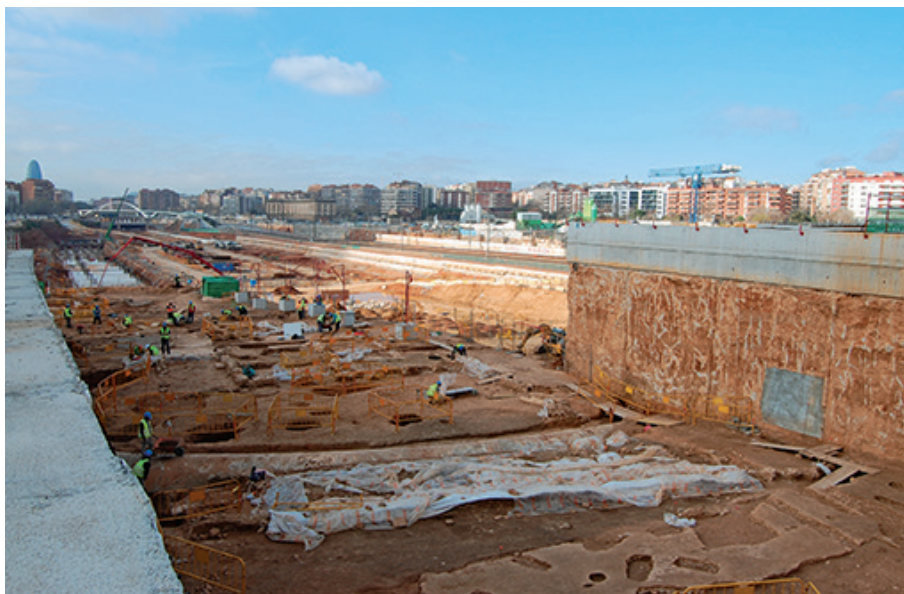
**Figure 1** View of the site during the archaeological excavation, with the city of Barcelona in the background. Photo: Sílvia Llobet

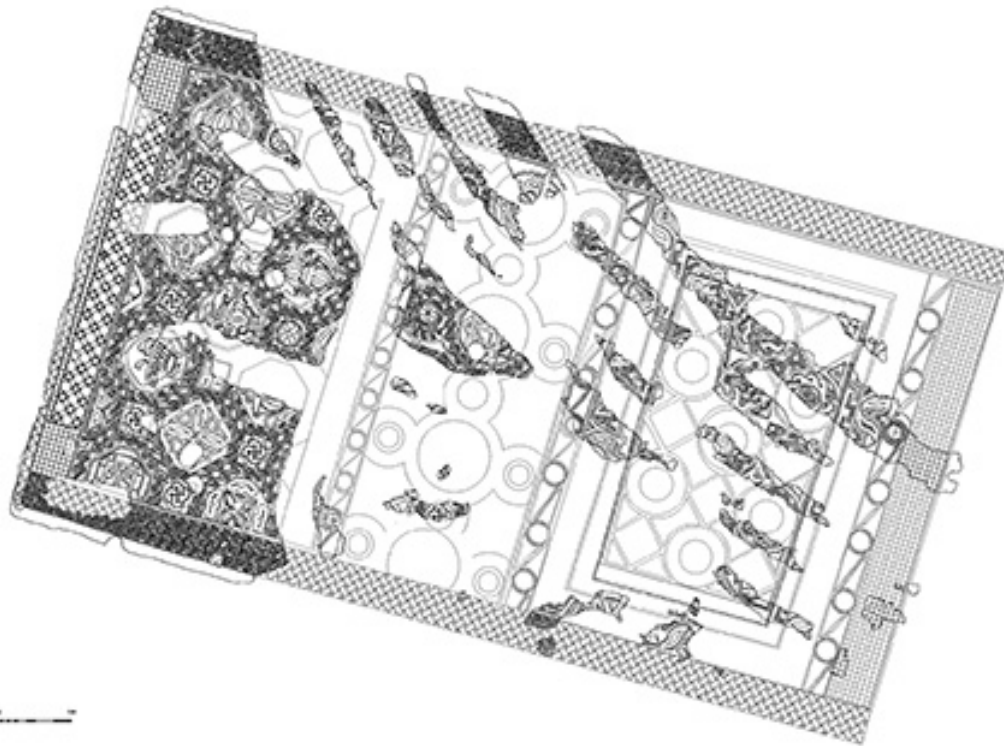
**Figure 3** Original design of the opus tessellatum template.

Because of its singularity and historical, archaeological, and artistic relevance, the entire opus tessellatum from the large reception hall was lifted when it was determined that the building was to be dismantled. The eastern half of the mosaic is in precarious condition. It presents numerous lacunae that are almost certainly the result of plow damage sustained after the land on which the villa was built became farmland. Based on the original measurements, the pavement has a surface area of 55 square meters, of which, unfortunately, only about 60 percent remains (fig. 3). Nonetheless, what does remain is

As for decoration, the tessellatum presents three panels with different decorations (fig. 3). A guilloche mat, however, is common to all. The first panel features geometric motifs forming an orthogonal pattern of circles and squares tangent to the vertex, with Solomon's knots and quatrefoils inside. This central part is edged by several bands: undulating and twisted ribbons with a trifold calix, fractionated meanders, a simple guilloche, and a border featuring an orthogonal pattern of adjacent squares. The central band displays a pattern of intersecting circles with star- and flower-shaped motifs inside. The room also includes an octagonal honeycomb pattern, the center of which is decorated with quatrefoils and a group of five craters with birds and peacocks flanked by swastikas, as well as a vase with flowers.

Prior to transferring the mosaic fragments to a new support, we had to create a design template for the mosaic (fig. 3). Using the orthophotograph of the mosaic as a basis, we established a hypothesis for the lacunae and replicated the missing decoration, obtaining a complete picture of the mosaic. A 1:1 scale copy of this sketch enabled us to correctly arrange the mosaic fragments and, where necessary, adjust the position of any fragments that may have shifted while underground. This was an extremely delicate process, since, as explained earlier, the mosaic fragments correspond to disjointed diagonal bands.

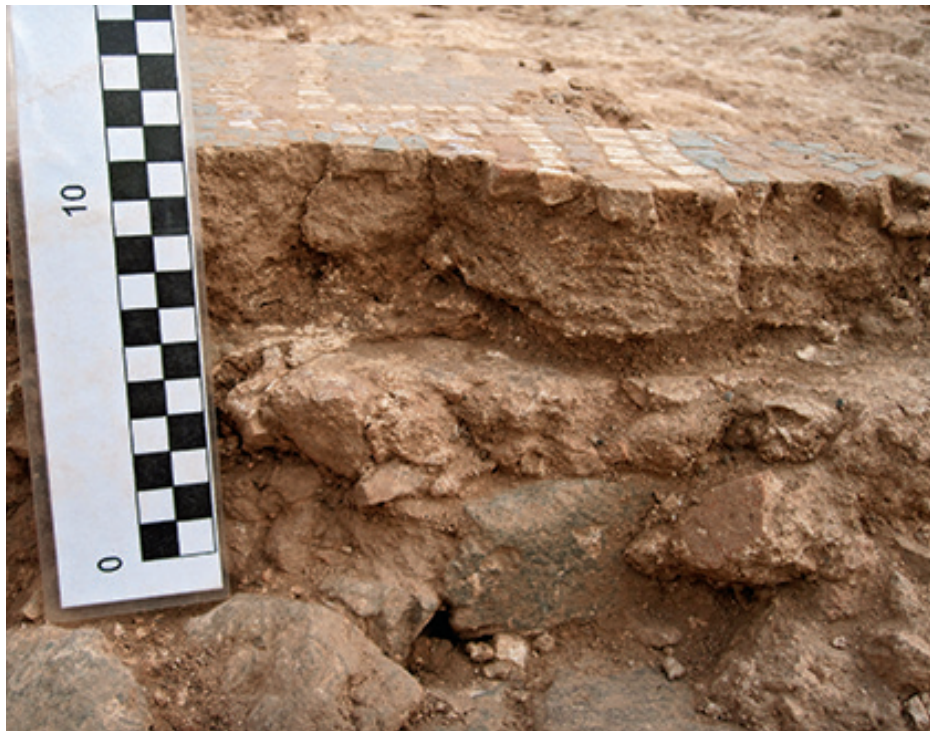
**Figure 4** Detailed view of the stratigraphy of the *opus tesellatum* atop the earlier *opus signinum* pavement. Photo: Silvia Lobet

Though Roman mosaics were normally built atop initial preparatory and leveling layers known as the *rudus* and *statumen*, that is not the case here, as the bottommost pre-

paratory layer consists of an *opus signinum* pavement with a clearly distinguishable *rudus* and *statumen*. This has two possible explanations: either the mosaic was built atop an earlier pavement or the *opus signinum* was built as a preparatory layer for the mosaic. Lifting the tessellatum gave us broader insight into the underlying *signinum*. It also made it possible to document widespread signs of chiseling and a leveling layer of sand that had been applied to form an even, flat work surface. From such evidence, we can infer that they are two overlapping pavements.

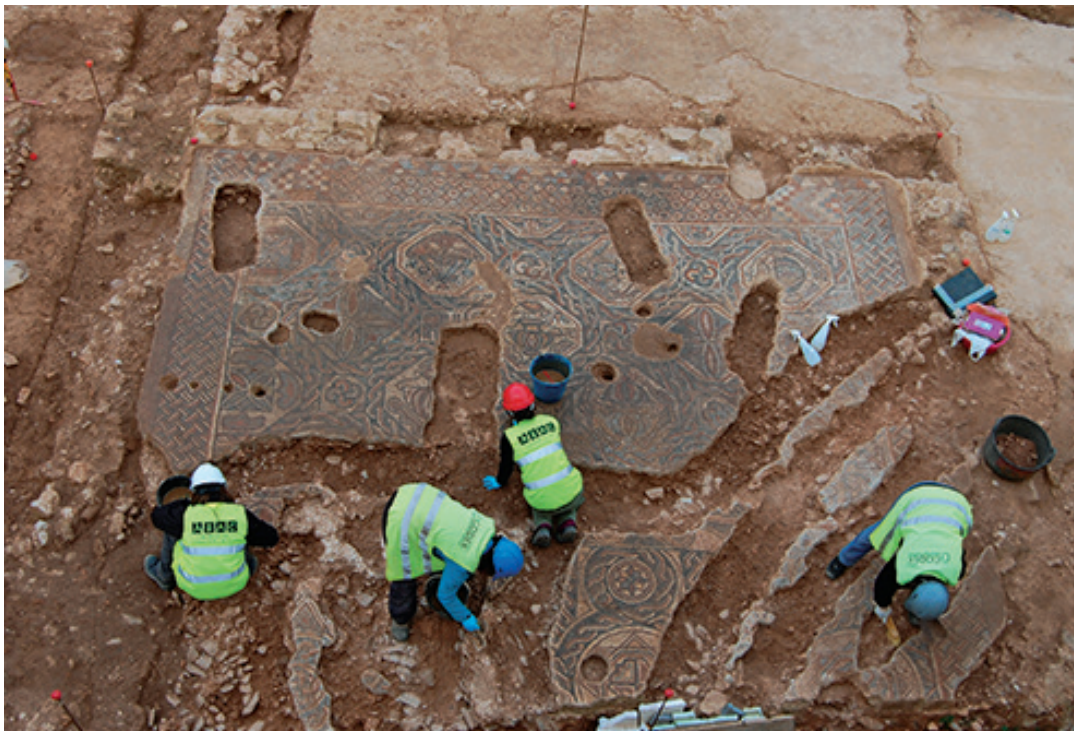
**Figure 5** Aerial view of the cleaning work on the part of the opus tessellatum excavated in 2014.  
Photo: Silvia Llobet

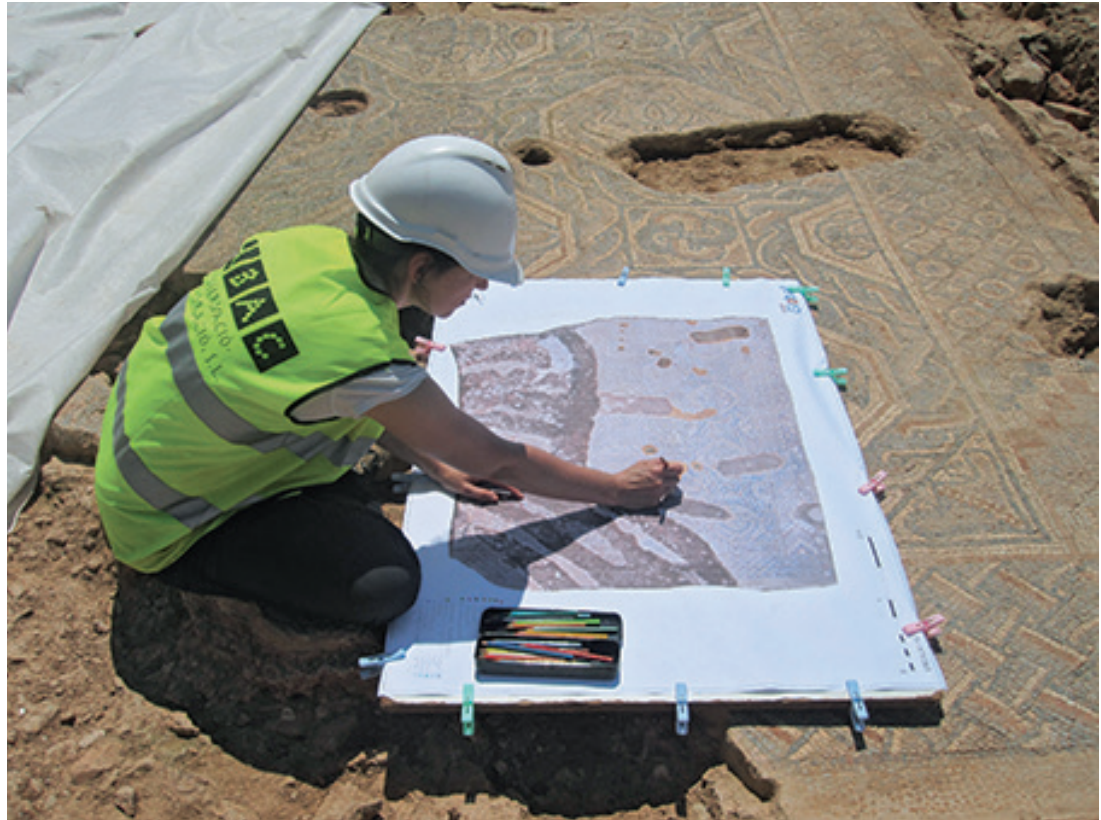
**Figure 6** Documenting the condition of the opus tessellatum on the ortho-photograph. Photo: Maria Molinas

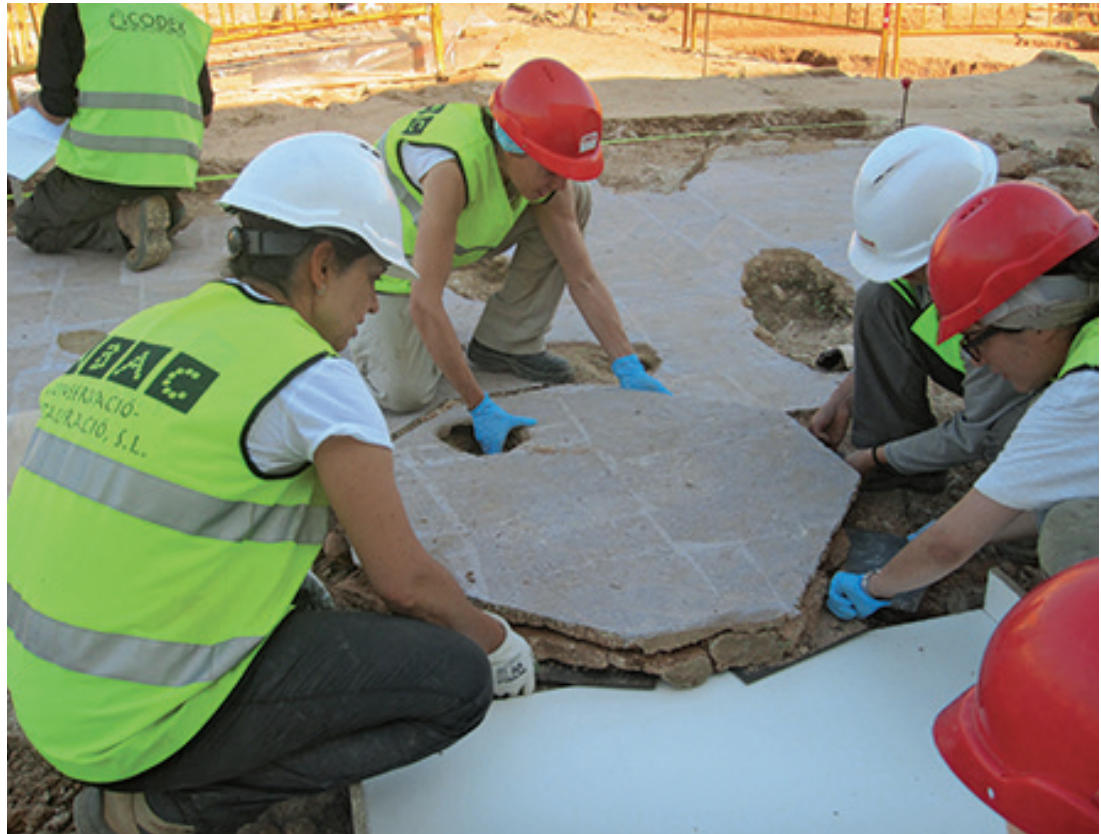
**Figure 7** Lifting fragments of the opus tessellatum during the 2014 campaign. Photo: Daniel Alcubierre

uses. The elongated mosaic fragments discovered in 2011 and corresponding to the part of the mosaic damaged by the plow were mostly lifted in their original shape and hardly cut.

In terms of facing, polyester gauze was used instead of traditional cotton gauze because, while just as strong, it is also transparent, enabling the mosaic to be more easily observed and monitored. The gauze was adhered to the surface of the tesserae using polyvinyl acetate.

When lifting the mosaic, we made sure to also lift all preparatory layers, that is, the tesserae plus the layers of mortar, because all this was considered an integral part of the piece. To lift the mosaic, we cut between the last layer of mortar and the *opus signinum*, enabling us to examine this layer following extraction. We applied the normal protocol: steel rods were inserted into the interstices between the tesserae to open cut lines, then the mortar was undercut—which proved quite simple—by inserting chisels between the last layer of mortar and the *signinum* (fig. 7). Last, we used steel plates to lift the mosaic and placed each fragment (of mosaic) inside a custom-made, stackable wood box.

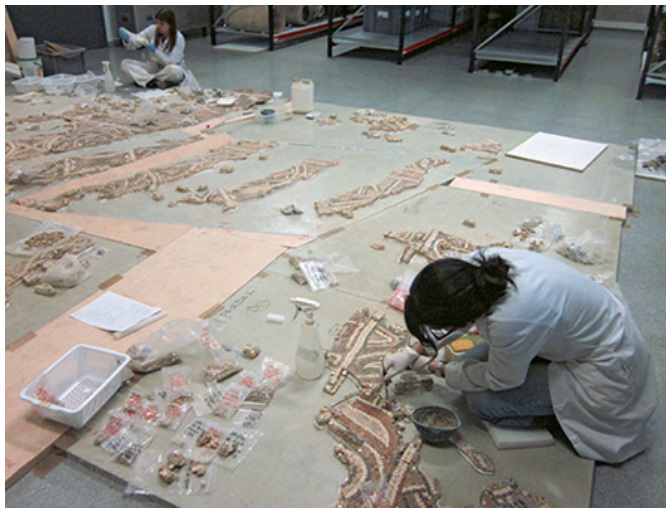
**Figure 8** Re-laying the fragments and tesserae recovered from the opus tessellatum onto the new honeycomb support. Photo: Silvia Llobet

we decided to fill small lacunae in between fragments and finish certain decorative lines with the tesserae, making the parts of the mosaic that had sustained substantial loss and the overall piece easier to understand. The entire re-laying process has been exhaustively documented (fig. 8).
